**hopkins home inspection**

## **Property Inspection Report**

1234 Any Place, Portland, OR  
Inspection prepared for: Joe Smith  
Date of Inspection: 6/24/2025

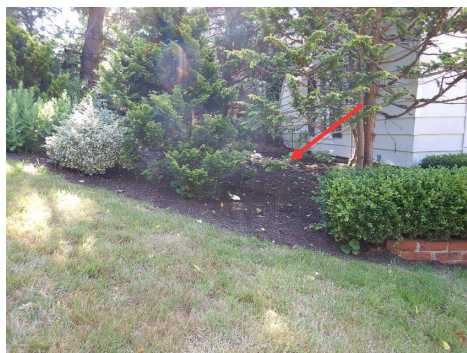
- **Improper slope of the site towards the foundation. This condition can result in increased moisture at the foundation, lower walls or in the basement or crawlspace areas and can lead to mold, rot and or insect damage and can also result in settlement to the building and other problems. Corrections are needed, recommend obtaining price estimates for needed corrections from a licensed drainage contractor.**
- Surface drains were visible at the property. These drains were not inspected and their connections and terminations were not determined. Recommend further information regarding the drainage system and where these drains drain to.

Improper drainage in areas

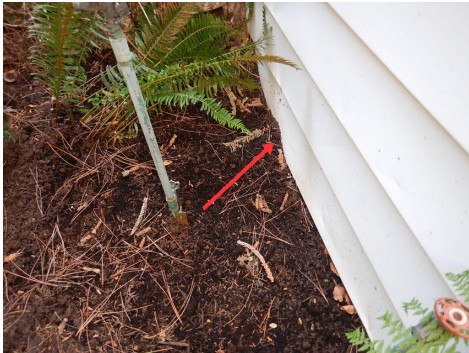
- Improper clearance between the ground and the building was present. A 6" minimum separation between the ground and building materials is recommended. Clearance of less than 6" can result in conditions conducive to moisture, rot and or insect damage. This condition needs to be carefully monitored and corrections are recommended.

Lower walls at ground

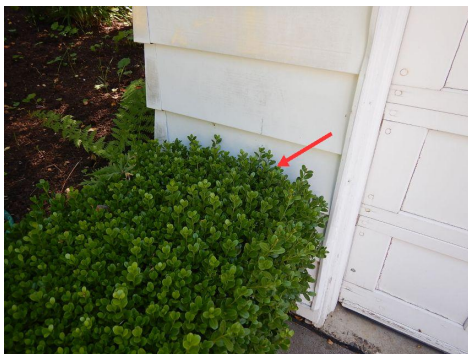
- Trees were close to or overhanging the roof. Removing debris from the gutters and roof will be needed on a regular basis.
- Vegetation at the property is overgrown. Heavy vegetation limited access to areas of the site and building, corrections are needed. The vegetation needs to be cut away from the building, a minimum 6" separation is recommended.

Trim plants away

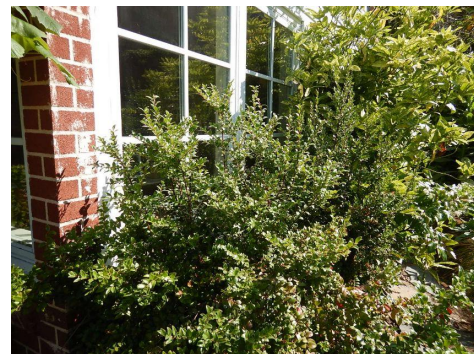
Overgrown vegetation

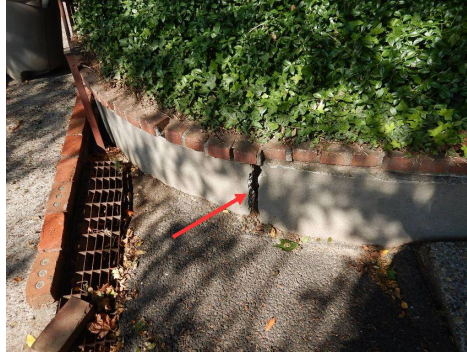
- Large cracks were present at the wall and the wall may need repair or replacement, recommend further evaluation of the wall by a masonry contractor or professional engineer.

Large crack at wall

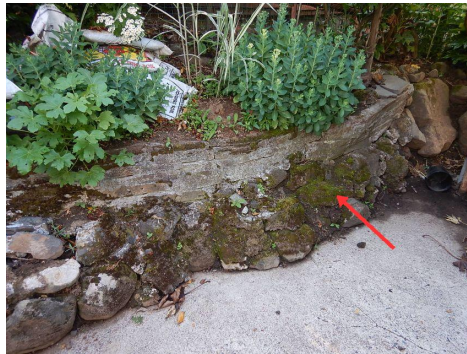
- Deterioration was present at the wall, recommend monitoring and maintenance.
- Significant displacement or movement was visible at the wall, the wall may need to be replaced or repaired. This condition needs to be evaluated by a licensed masonry contractor or professional engineer.

Displacement at wall

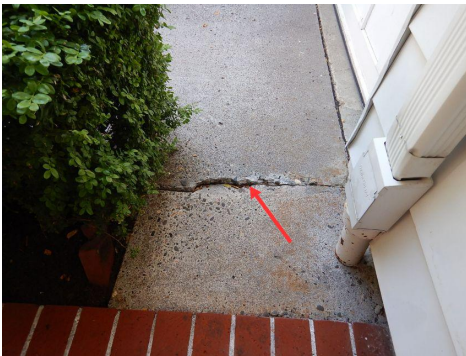
- Trip hazards were present at the walkways, repairs are needed for safety.

Trip hazards

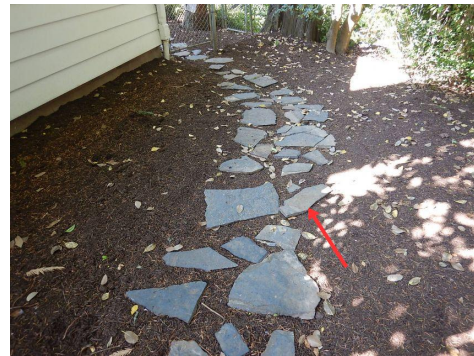
Trip hazards

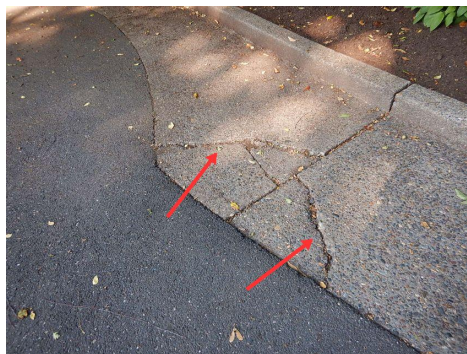
- Trip hazards were present at the driveway, repairs are needed for safety.

Trip hazards at driveway

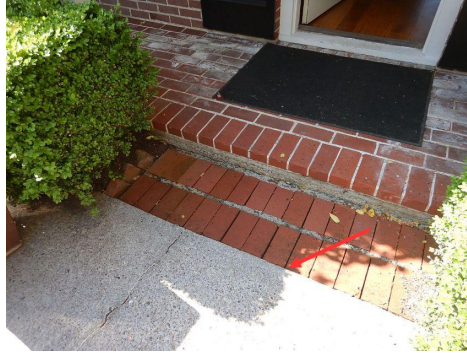
- Uneven spacing and surface of some steps. This condition is potentially hazardous and corrections are recommended.

Uneven surface

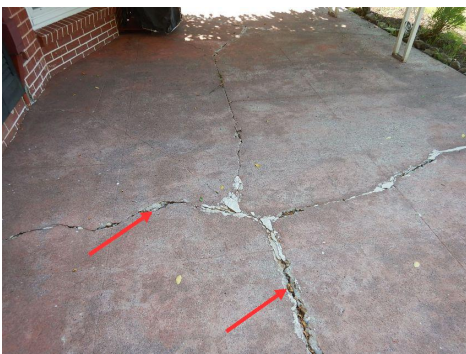
- Large cracks were present at the patio surface, this condition needs to be monitored repairs may be needed.
- Portions of the patio surface were raised or settled, this condition needs to be monitored and corrections may be needed if trip hazards are present.
- Cover type: Metal roof panels over a metal structure.
- Trip hazards were present at the patio surface, repairs are needed for safety.
- Condition: The cover appears to leak, repairs are needed. The cover is in poor condition and needs to be removed or replaced.

Large cracks and trip hazards

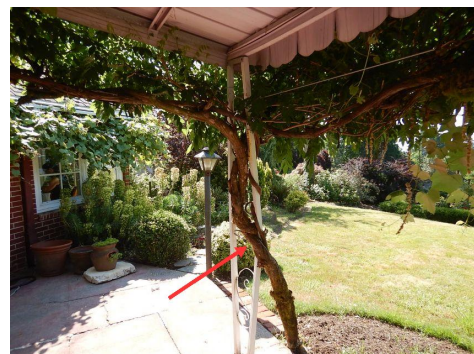
Cover in poor condition

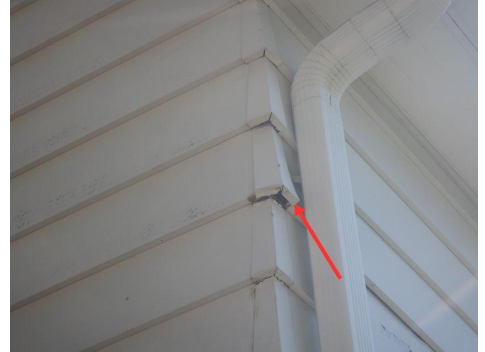
Loose caps

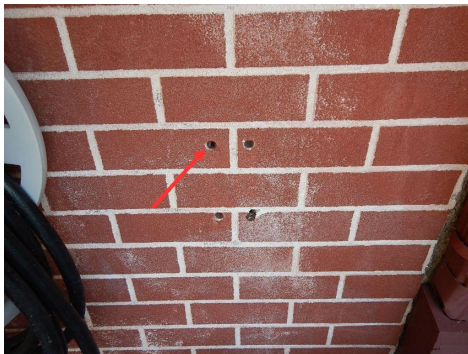
- Common cracks or openings were present at the siding or wall components. These openings need to be sealed as part of regular maintenance.
- Areas of the brick or stone siding were at the ground level and in soil contact. This condition is conducive to insect and or rot damage. Recommend further evaluation by a specialty siding inspector.
- Rot damage was present at areas of the siding, repairs are needed.
- Some corner caps were loose or damaged, corrections are needed.
- The siding appears to be improperly installed in areas. Recommend further evaluation from a specialty siding contractor or inspector, the siding may need to be repaired or replaced.

Seal openings at siding

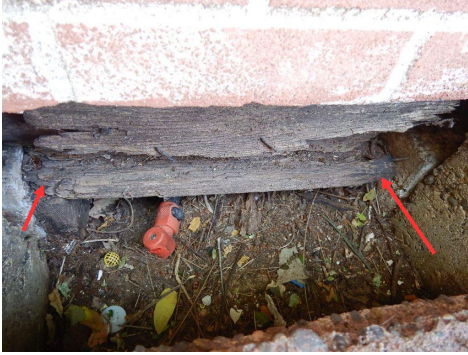
- Common cracks or openings were present at the trims or trim to wall transitions. These openings need to be sealed as part of routine maintenance.
- Storm windows were installed in areas and prevented full view and inspection of the windows and window trims. The storm windows were not inspected or operated.
- Moisture damage was present in areas, these areas need to be carefully monitored and are likely to need repairs.
- Rot damage was present in areas, repairs are needed.

Rot at vents

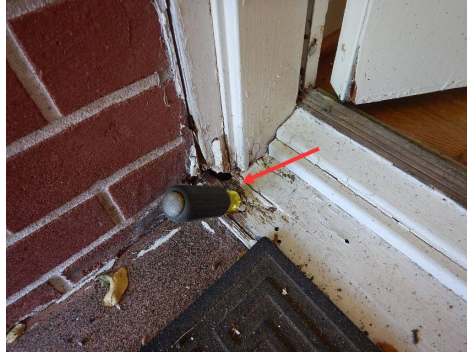
Rot at trim

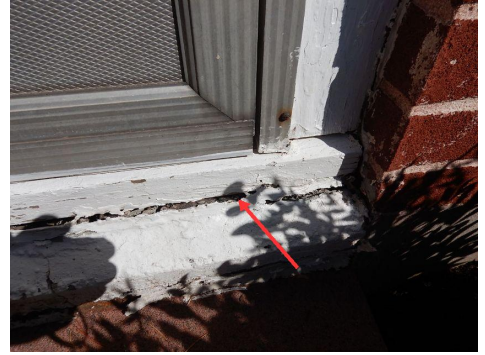
Seal openings

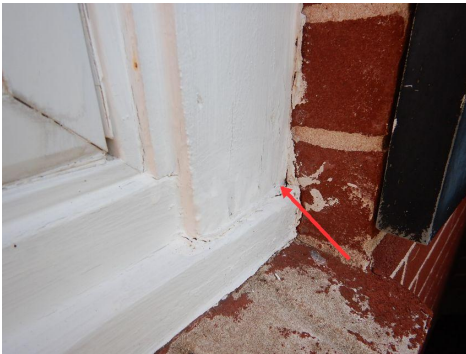
Rot damage

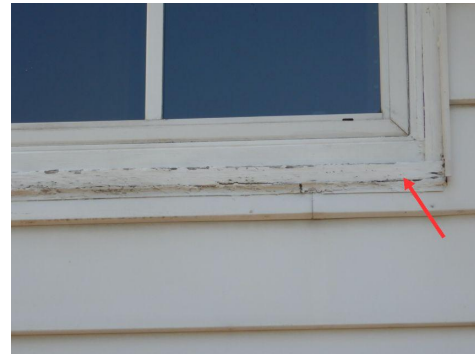
Moisture damage

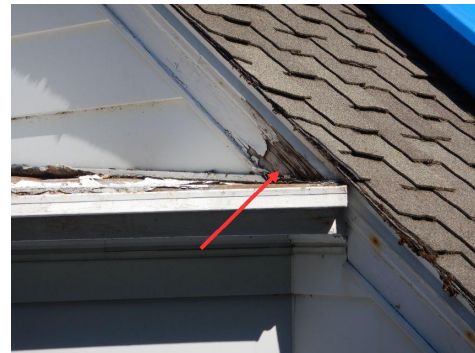
- Heavy wear or damage was visible at areas of the fascia boards, repairs or replacement may be needed.
- Moisture damage was visible in areas, these areas need to be carefully monitored and are likely to need repairs.

Moisture damage at roof edge

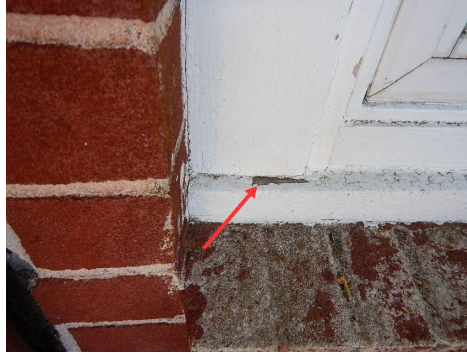
- Areas of peeling or damaged paint were present, maintenance and repairs are needed. Recommend obtaining price estimates from a licensed painting contractor.

Damaged paint

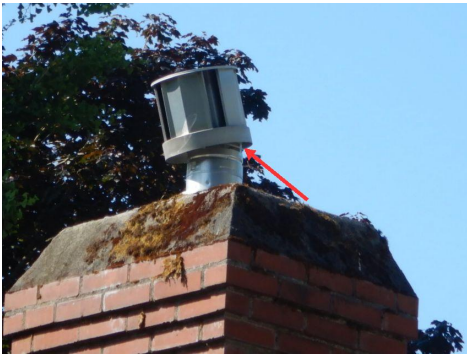
Loose cap

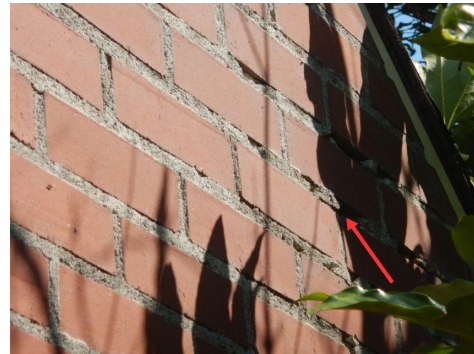
- Deterioration to the mortar was visible. Repairs to the chimney are needed, recommend obtaining price estimates for a licensed chimney contractor.

Deterioration at mortar

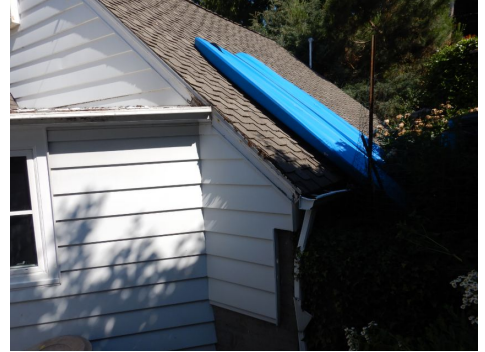
Stored items on roof

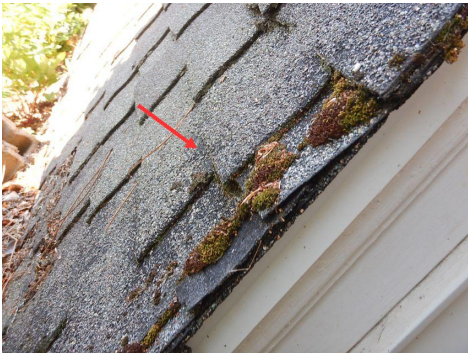
- The roof was in contact with the ground at areas of the garage. This condition will result in leaks, corrections are needed.
- The shingles appear to have excessive wear and may be prematurely wearing out. The shingles may be defective or improperly installed, recommend further evaluation by a licensed roofing contractor.
- Heavy deterioration was visible at the metal portions of the roof. This condition needs further evaluation from a licensed roofing contractor, repairs or replacement are needed.

Heavy wear at roof

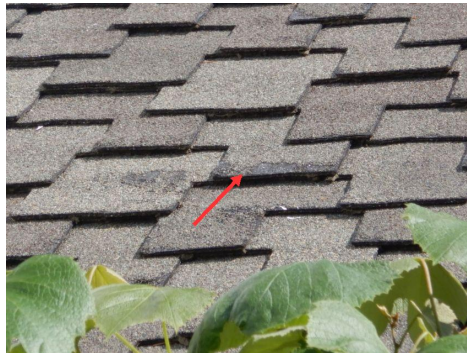
Deterioration at surface

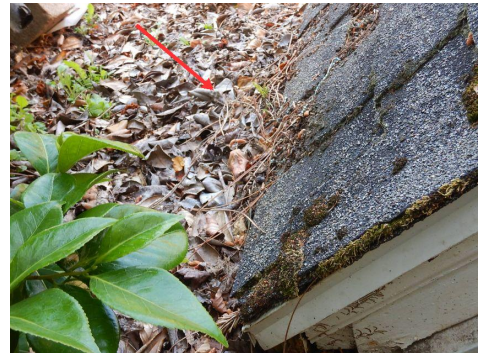
Roof at ground

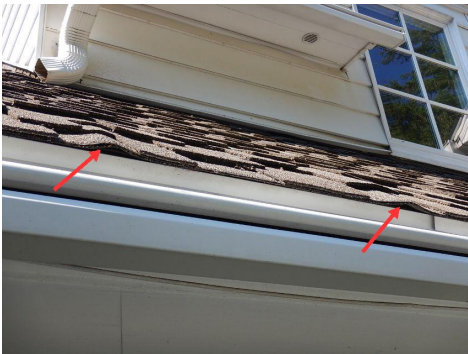
Lifting and loose shingles

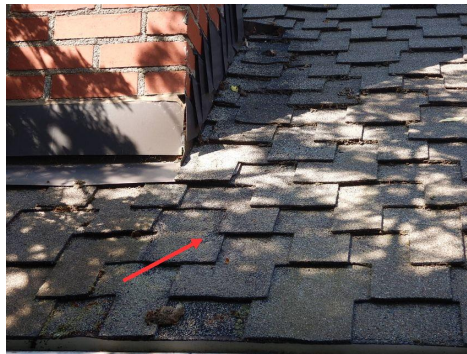
Deterioration at surface

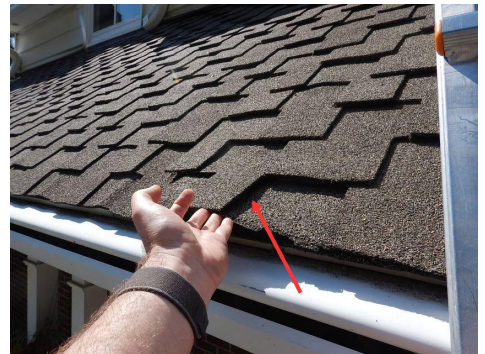
Loose shingles

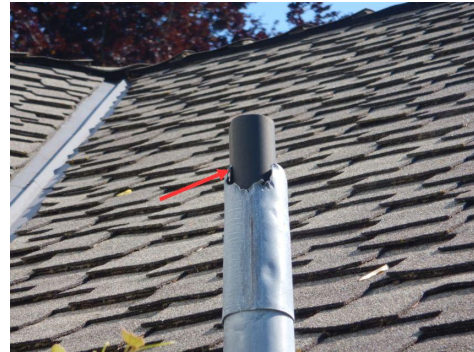
Damaged flashing

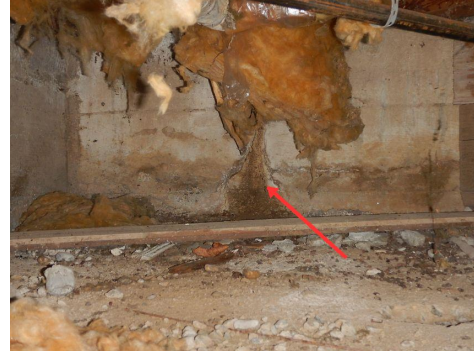
Moisture stains at foundation

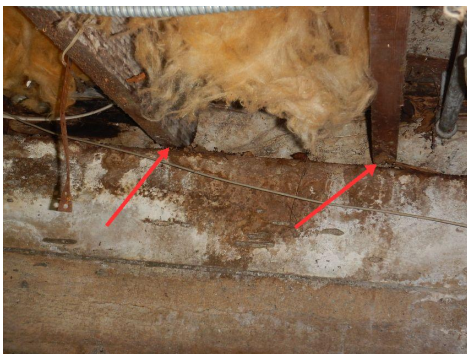
- Rot damage was present at areas of the framing, repairs are needed.
- **Insect activity or damage was present at areas of the framing, repairs and evaluation by a licensed pest control operator are needed.**

Significant rot and insect damage

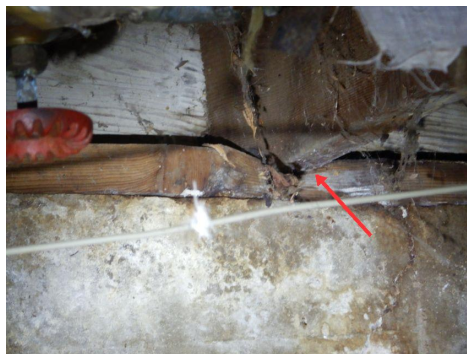
Significant rot and insect damage

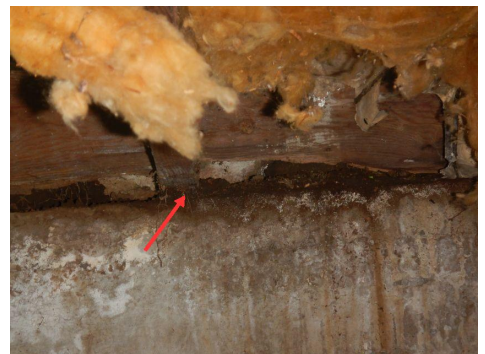
Significant rot and insect damage

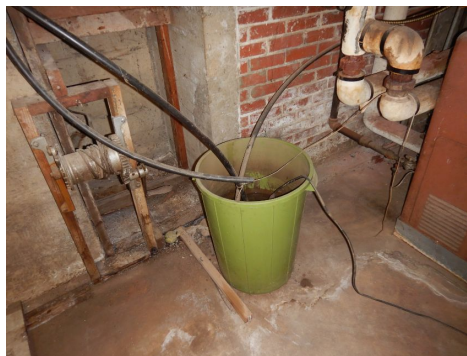
- A sump pump was installed in the basement. The pump is designed to pump water out of the basement. The pump was not operated or inspected but does not appear to be professionally installed. Information regarding the pump, when it was installed, its operation, where it drains to and how frequently it runs is needed. The pump needs to be carefully monitored and if it stops operating water may collect in the basement. The pump is connected to an electric circuit and will not operate if the power is off. The pump may indicate frequent or excessive water entry into the basement. Excessive moisture in the basement can lead to many problems including but not limited to mold, rot, insect damage and damage to the foundation or framing. The basement needs to be carefully monitored for water entry and excessive moisture. Recommend further evaluation of the pump and basement drainage by a licensed drainage contractor.

Pump system in basement

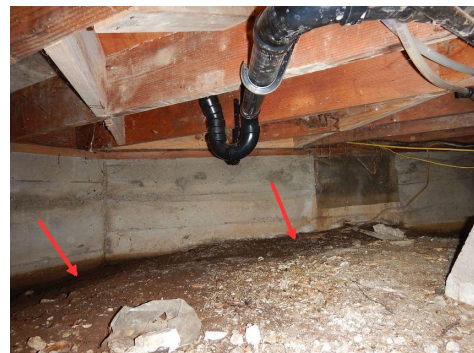
Moisture in crawlspace

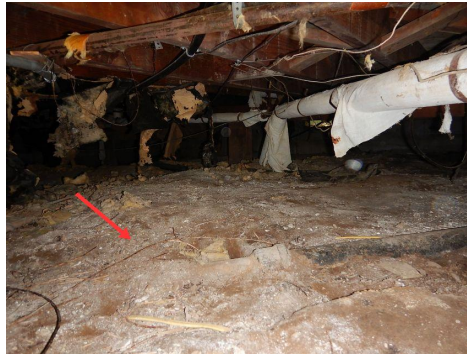
- A vapor barrier was not installed over areas of exposed soil in this crawlspace. This could result in increased moisture in the crawlspace and could result in mold, rot, insect damage or other problems. A 6 mil black plastic vapor barrier needs to be installed over all exposed soil.

Exposed soil in crawlspace

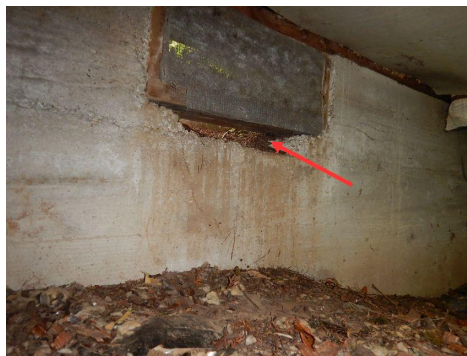
- Openings were present at some of the crawlspace/foundation vents. These vents need to be repaired to help keep animals out of the crawlspace.

Damaged vents

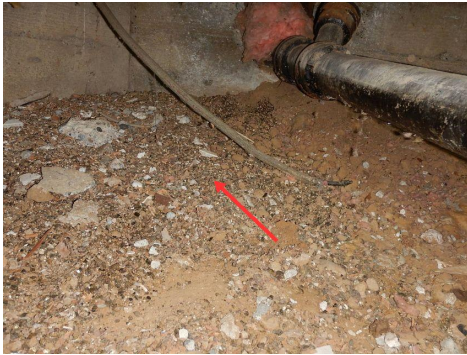
- Vermiculite type insulation was visible in areas. This insulation may contain asbestos and is potentially hazardous when disturbed. This is a hazardous material to have on the ground in the crawlspace area, recommend having the material tested and properly removed.

Vermiculite in crawlspace

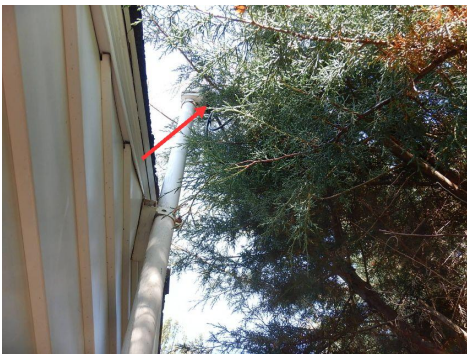
- The service entrance is overhead.
- The overhead service wires were touching trees, recommend contacting the utility company for further evaluation.
- Portions of the service entry conduit appears to be loose or improperly supported, recommend further evaluation by a licensed electrician.

Wires at tress

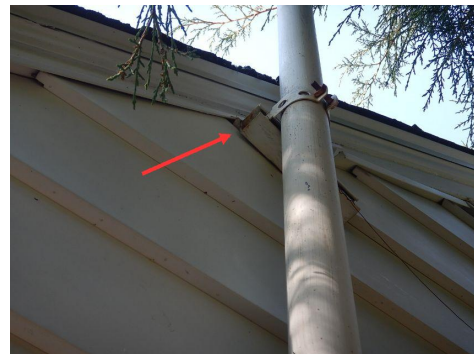
Conduit appears loose

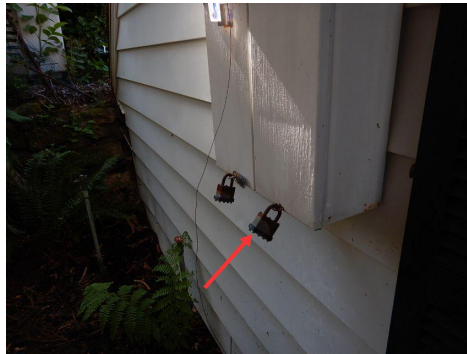
- Access to the panel was blocked. A lock was installed at the panel and the lock was rusted shut. The panel cover was not removed and the panel was not inspected. Further evaluation of the panel is needed when proper access is provided.

Panel locked

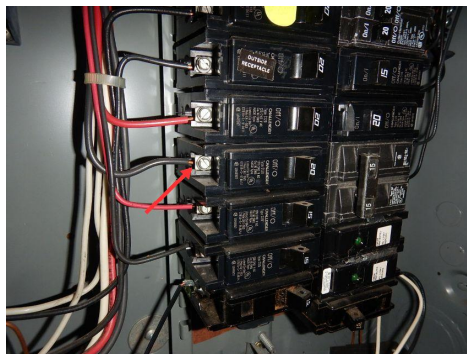
- Breaker(s) at the panel appear to be too large for the wires connected. This could result in a circuit overload or other unsafe condition. These circuits need to be evaluated by a licensed electrician and repaired as necessary.
- The panel appears to be close to full capacity at this time. Improvements to the electric system or adding circuits may require installing a sub panel or upgrading this panel.

Breaker too large for wire

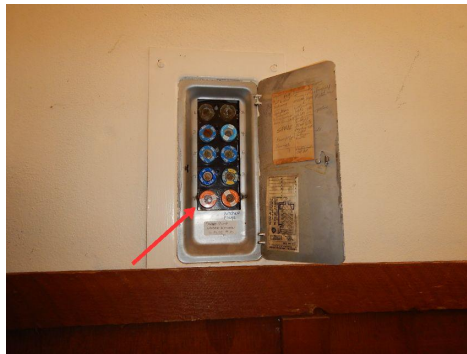
- This is a fuse box. Fuse systems are considered obsolete by current standards, upgrades to the electrical system are needed. Obtaining homeowners insurance can be complicated by the fuse system. Recommend obtaining price estimates for needed upgrades from a licensed electrician. The inspector does not remove the covers from fuse panels.

Fuses at obsolete panel

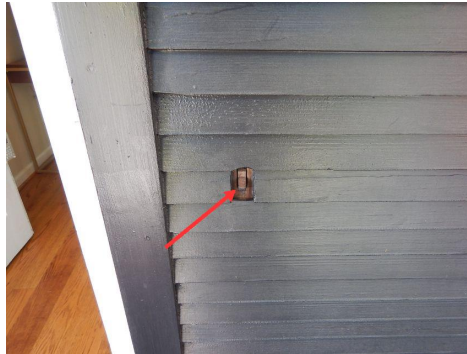
- Some exterior switches did not have proper exterior covers installed, corrections are needed.
- Unable to determine the function of some switches, recommend further information regarding these switches.
- Some lights did not operate, this may be the result of burnt out bulbs. Need to have the light operation verified.

Improper exterior switch

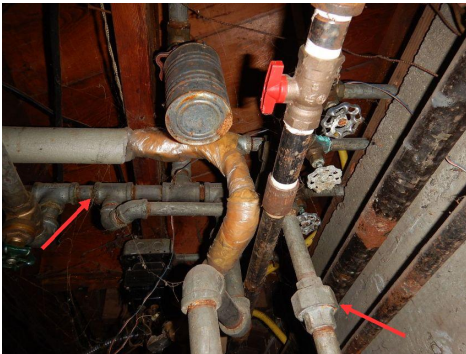
- The older steel pipes in use are approaching the end of their useful life, recommend monitoring these pipes and budgeting for future replacement. Recommend obtaining price estimates for pipe replacement from a licensed plumber.
- Moderate corrosion was visible on the supply pipes. This is an indication of pipe age, the pipes need to be monitored.
- Copper pipe was improperly connected to galvanized steel pipe in areas. This type of connection will lead to premature corrosion, corrections by a licensed plumber are recommended.

Pipes at end of life

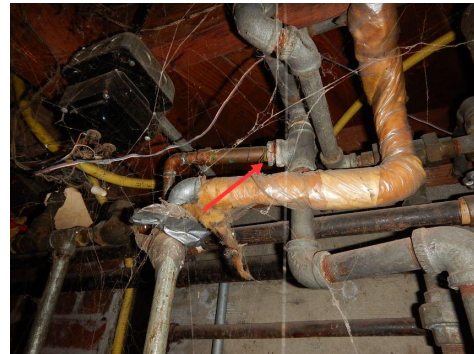
Improper connection

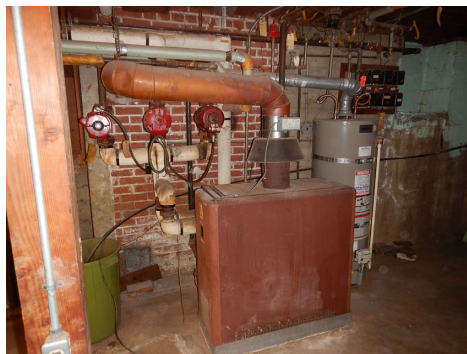
- Moisture stains around the boiler may indicate leaks or damage at the unit.
- The boiler was in poor condition and needs to be fully evaluated by a licensed HVAC or boiler contractor.
- The boiler did not respond properly to operating controls and was not operated. Need full evaluation of the boiler system by a licensed HVAC or boiler contractor.

Boiler needs evaluation

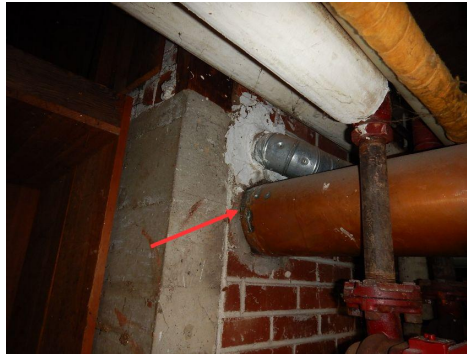
- The unit appears to be venting into an unlined masonry chimney. This connection may have been allowed at time of installation, but a flue liner is recommended for improved draft and safety.

Boiler venting into unlined chimney

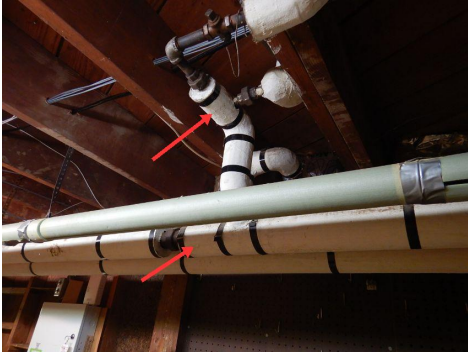
- Older insulation was present on some of the heat distribution pipes. This material was not tested or identified but may contain asbestos. Some of this material was loose or damaged and may be hazardous, recommend having this material tested and properly identified and sealing, encapsulating, or proper removal as necessary. Further information regarding asbestos can be found by searching at [www.oregon.gov](http://www.oregon.gov) or at the U.S. Environmental Protection Agency's web site [www.epa.gov](http://www.epa.gov)
- No heat source found at the upper floor, this is common at some older homes but most regulations require a dedicated heat source in all bedrooms and living spaces. Improvements to the heat distribution system are recommended.
- The radiators or convectors were cold and do not appear to be heating. Need further evaluation of these units by a licensed HVAC contractor.

Older covering may contain asbestos

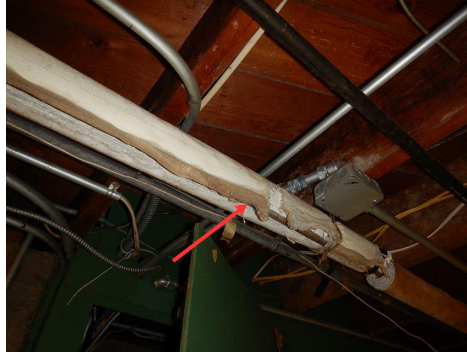
Damaged covering may contain asbestos

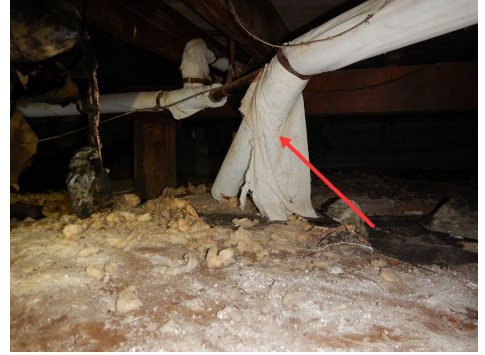
Damaged covering may contain asbestos

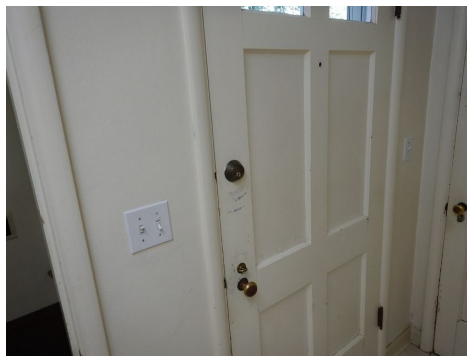
- Location: Front entry door #2
- The older glass at the doorway does not appear to be tempered safety type. This is common at older doors but is a potential safety hazard. Consider having the glass at the door area replaced with tempered safety type.
- Some locks are keyed on the inside of the door. This can pose an exit hazard, recommend having the locks replaced with types that can be opened from the interior without a key.
- The door was locked and no key was provided, the door was not operated or inspected.

Locked deadbolt

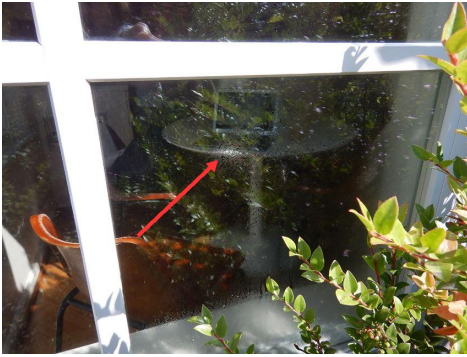
Fogged glass

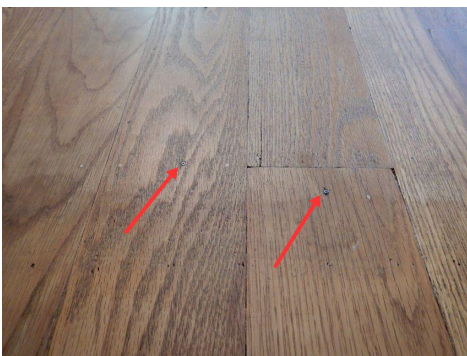
- Heavy wear to areas of the floor coverings.
- Nails were lifted at the flooring in areas, this is potentially hazardous and corrections are needed.
- Areas of the wood flooring were warped. This may be the result of improper installation or excess moisture in areas. Recommend further evaluation from a licensed flooring contractor, the floor in these areas may need to be replaced.

Nails lifting at floor

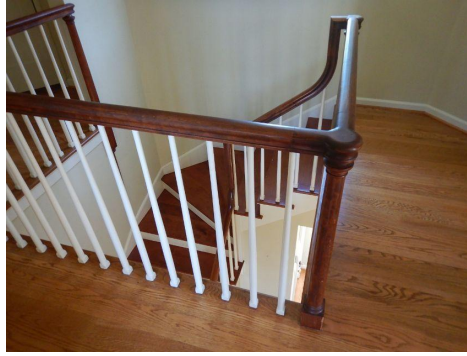
- The fall railing at the top of the stairway area was low, this is common at older buildings but can be potentially hazardous, recommend improvements to the railing for safety.

Low fall railing, openings too wide

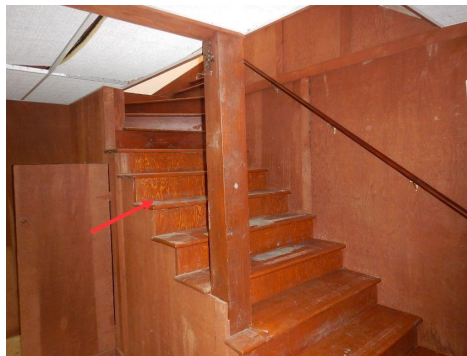
- Only a partial hand rail was installed, need to install proper hand rails for safety.
- Railings were not installed at the open areas of the stairway, corrections are recommended.

No railing at side

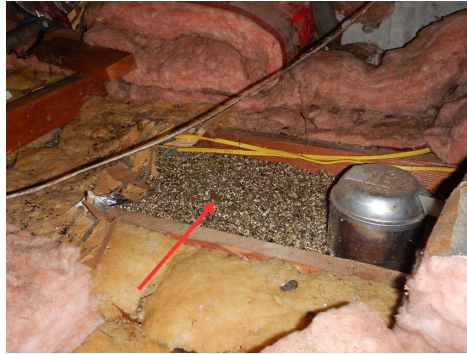
insulation looks like small shiny gravel. This insulation may contain asbestos. Testing for asbestos is beyond the scope of this inspection. Do not disturb this material with out having it tested first. Further information regarding asbestos can be found at the U.S. Environmental Protection Agency's web site [www.epa.gov](http://www.epa.gov) or by searching at [www.oregon.gov](http://www.oregon.gov)

Insulation may contain asbestos

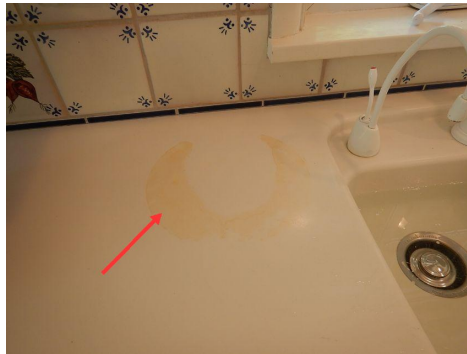
- The counters were stained in areas.

Stained counter

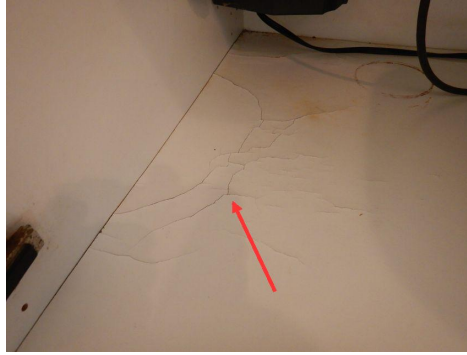
- Moisture damage was visible below sink, this is an indication of prior leaks, repairs to the plumbing or cabinet may be needed.

Moisture damage under sink

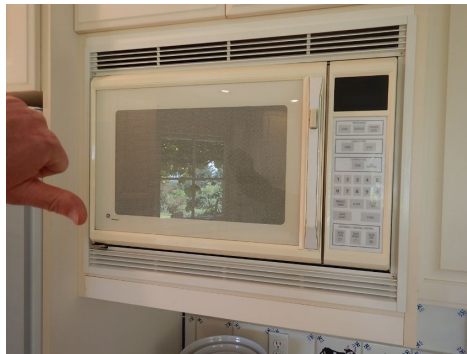
- The microwave did not operate and needs to be repaired or replaced.

Microwave not operating

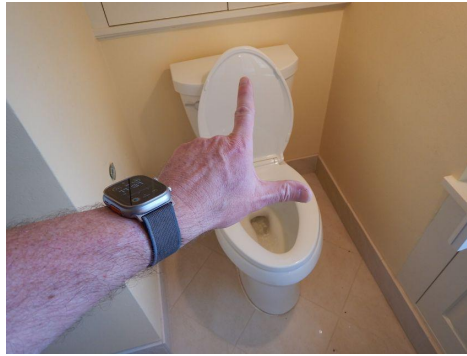
- The toilet was loose at the floor and the seal between the toilet and floor may be compromised. The seal between the toilet and floor needs to be replaced by a licensed plumber.

Loose toilet

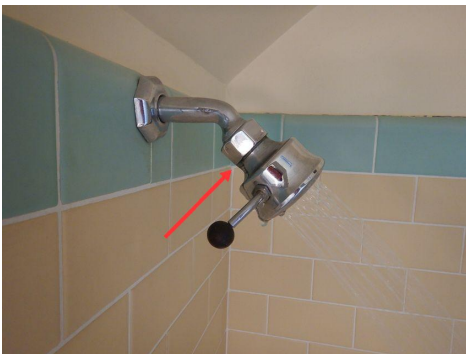
- Tub fixtures: The tub faucet was leaking while in use and needs to be repaired or replaced by a licensed plumber.
- The diverter was not operating properly, corrections are needed.
- Shower head: The shower head was leaking and needs repair.

Shower head leaking

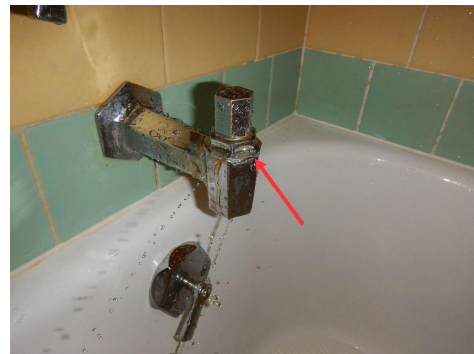
Diverter not operating properly

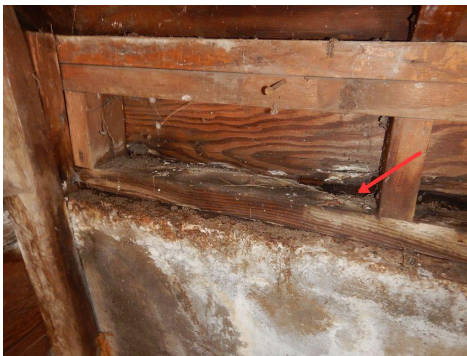
- Earth to wood contact was present at the garage area framing or walls. This condition will lead to moisture, rot and or insect activity or damage. These areas need to be carefully monitored and repairs may be needed.
- Rot damage was present at areas of the framing, repairs are needed.
- The garage structure is significantly out of plumb and needs structural support or other correction.
- No fire wall present between the garage and living spaces of the building. The garage may have been constructed prior to modern fire code requirements. Improvements to establish fire separation between the garage and other areas of the building are recommended.

Rot and insect damage

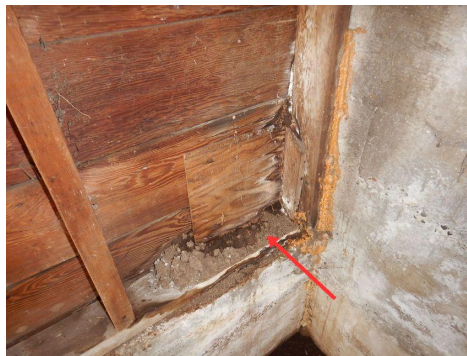
Rot and insect damage

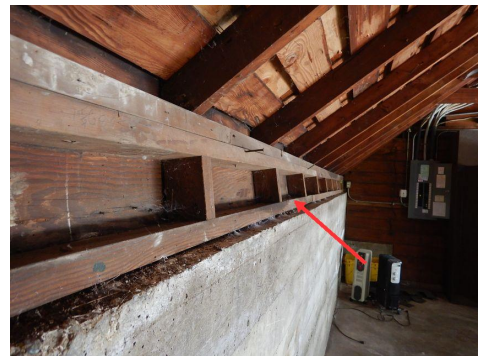
Lean at back wall

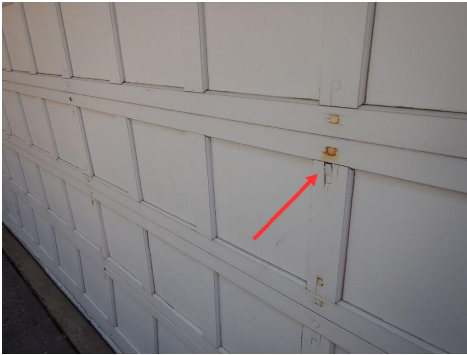
- Heavy wear to the door, this condition needs to be monitored and repairs or replacement may be needed.
- Automatic door opener: The opener did not operate, repairs or replacement needed. The reverse function needs to be verified when the door is operational.

Heavy wear at door

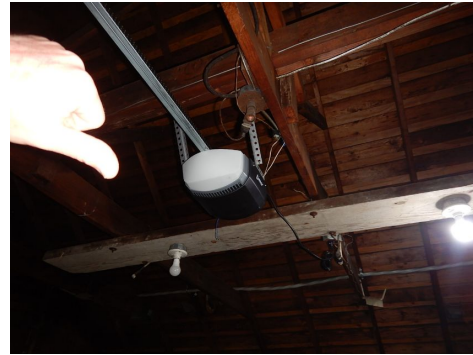
Opener did not operate
