**hopkins home inspection**

## **Property Inspection Report**

1234 Any Place, Portland, OR  
Inspection prepared for: Joe Smith  
Date of Inspection: 6/24/2025

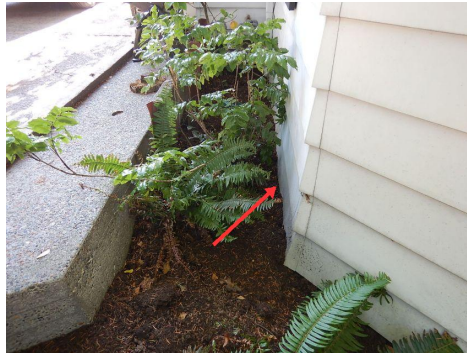
- Improper clearance between the ground and the building was present. A 6" minimum separation between the ground and building materials is recommended. Clearance of less than 6" can result in conditions conducive to moisture, rot and or insect damage. This condition needs to be carefully monitored and corrections are recommended.

Lower walls at ground

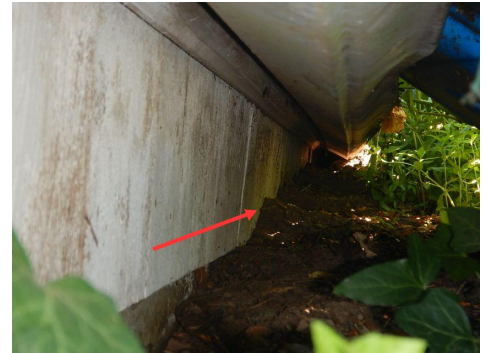
Lower walls at ground

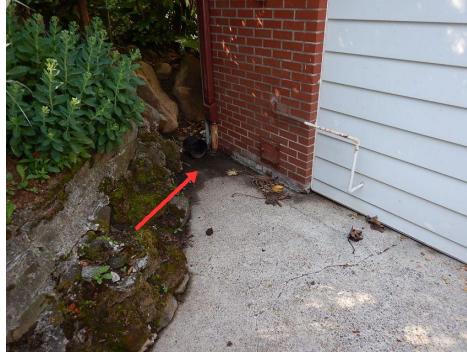
- A drain was present at the patio area, the drain was not operated or inspected. Recommend further information regarding the operation of the drain and where it drains to.
- Evidence of poor drainage at the patio surface. The patio may collect water or not drain well. This condition needs to be monitored and corrections may be needed.
- Trip hazards were present at the patio surface, repairs are needed for safety.

Poor drainage at patio

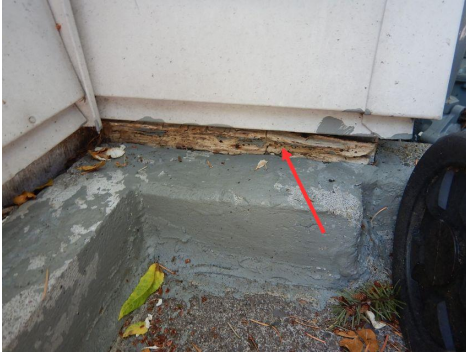
- Common cracks or openings were present at the siding or wall components. These openings need to be sealed as part of regular maintenance.
- Areas of the brick or stone siding were at the ground level and in soil contact. This condition is conducive to insect and or rot damage. Recommend further evaluation by a specialty siding inspector.
- Rot damage was present at areas of the siding, repairs are needed.
- Some corner caps were loose or damaged, corrections are needed.
- The siding appears to be improperly installed in areas. Recommend further evaluation from a specialty siding contractor or inspector, the siding may need to be repaired or replaced.

Rot at wall

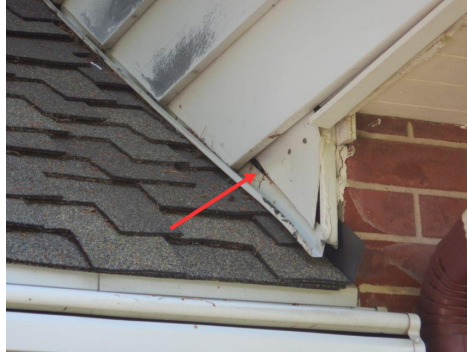
Improper transitions

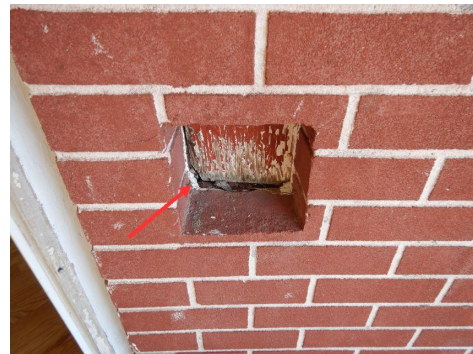
Seal openings

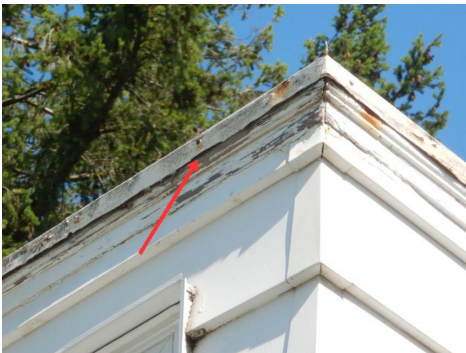
- Heavy wear or damage was visible at areas of the fascia boards, repairs or replacement may be needed.
- Moisture damage was visible in areas, these areas need to be carefully monitored and are likely to need repairs.

Wear at fascia

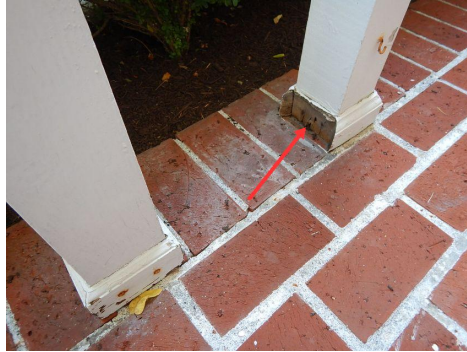
- Rot damage was present at areas of the porch, repairs are needed.

Rot at post

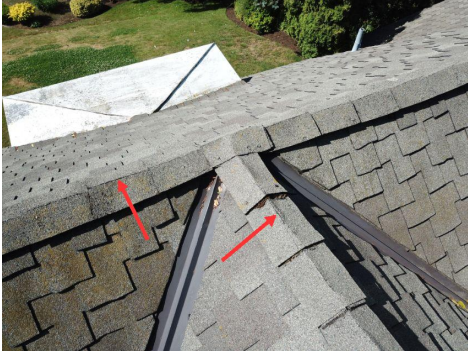
- Some roof nails were exposed and need to be sealed.
- Deterioration to the roofing surface was visible, this condition needs to be monitored.
- Some shingles were loose and need repair.
- Heavy wear was visible at the hip or ridge shingles, repairs are likely to be needed.
- Stored items were present on the roof in areas. This is not recommended and may lead to wear and damage at the roof.

Damage at ridge shingles

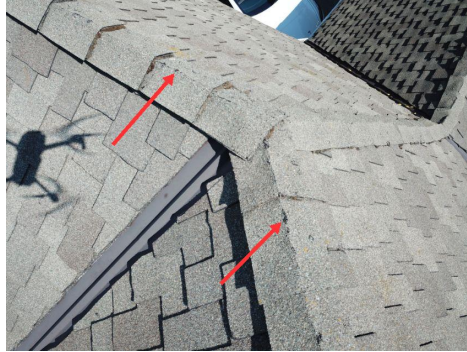
Damaged ridge shingles

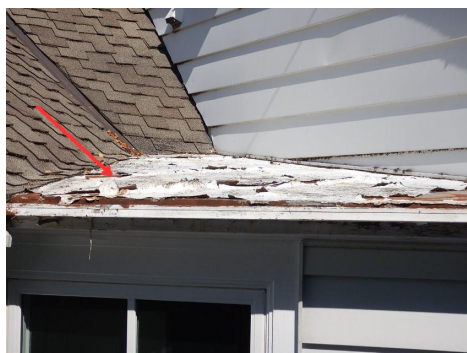
- The roof was in contact with the ground at areas of the garage. This condition will result in leaks, corrections are needed.
- The shingles appear to have excessive wear and may be prematurely wearing out. The shingles may be defective or improperly installed, recommend further evaluation by a licensed roofing contractor.
- Heavy deterioration was visible at the metal portions of the roof. This condition needs further evaluation from a licensed roofing contractor, repairs or replacement are needed.

Heavy wear at metal roof

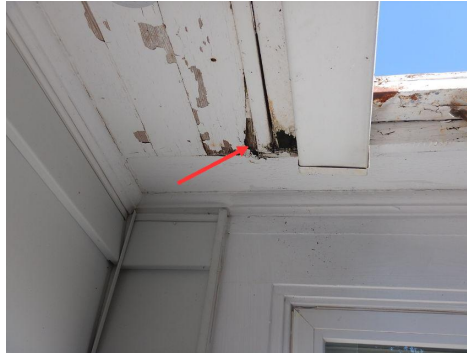
- Moisture damage visible at areas of the roof edge indicate leaks at the roof surface, further evaluation by a licensed roofing contractor is needed.

Possible leak at metal roof

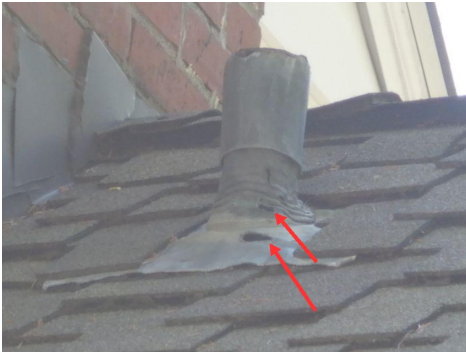
- Some plumbing vent flashings were damaged and need repair.
- Areas of improper flashing were visible, repairs by a licensed roofing contractor are needed.

Damaged flashing

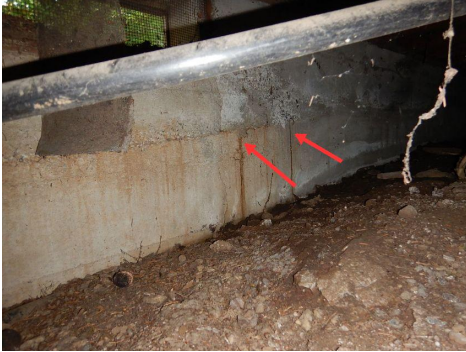
- Common vertical settlement type cracks were visible in areas. These cracks need to be monitored for indications of change or continued settlement.
- Moisture stains were visible at areas of the foundation. This is an indication of prior leaks or moisture at the foundation. Recommend further information regarding any prior leaks or water entry at the foundation. This condition needs to be monitored and corrections may be needed if leaks continue.

Moisture stains in crawlspace

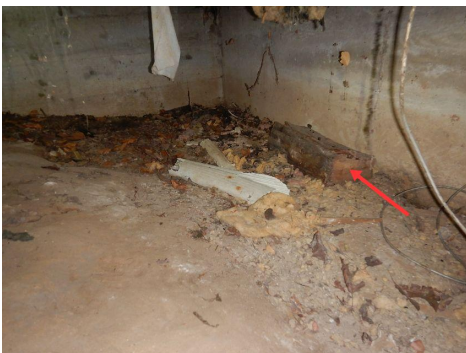
- Animals have been entering this crawlspace and have damaged the insulation in this crawlspace. All damaged insulation needs to be replaced and all animal waste needs to be removed from the crawlspace. Corrections are needed to help keep the animals out of the crawlspace area. Further evaluation of the animal activity in the crawlspace can be made by a licensed pest control operator if needed.

- Wood or cellulose debris was present in the crawlspace, this condition is conducive to wood destroying insect activity. All wood and cellulose debris needs to be removed from the crawlspace.

Wood debris and animal waste

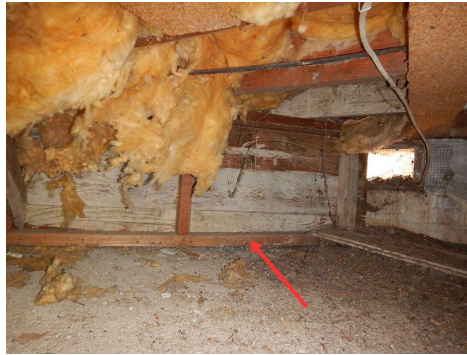
Earth to wood contact in crawl

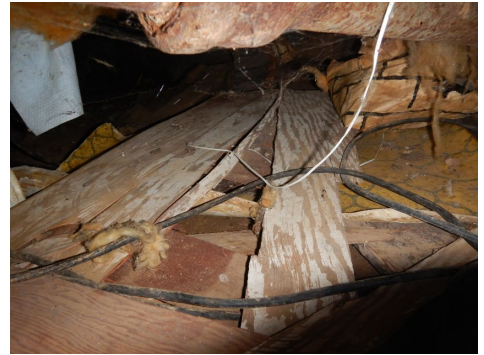
Debris in crawlspace

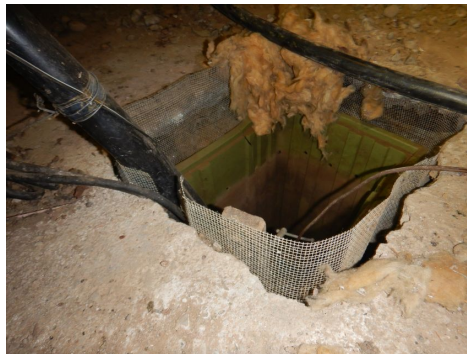
- A sump pump was installed in this crawlspace. The pump is designed to pump water out of the crawlspace area. The pump and drainage system was not operated or inspected but does not appear to be professionally installed. Information regarding the pump, when it was installed, its operation, where it drains to and how frequently it runs is needed. The pump needs to be monitored and if it stops operating water may collect in the crawlspace. The pump is connected to an electric circuit and will not operate if the power is off. The pump installation may be an indication of frequent or excessive water entry into the crawlspace. Excessive moisture in the crawlspace can lead to many problems including but not limited to mold, rot, insect damage, and damage to the foundation or framing. The crawlspace area needs to be carefully monitored for water entry and excessive moisture. Recommend further evaluation of the pump and drainage system by a licensed drainage contractor.

Drain in crawlspace

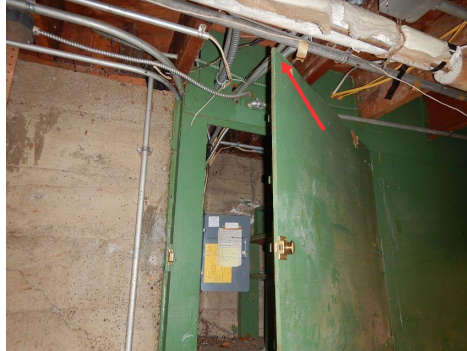
- Access to the panel was blocked by a cabinet door that will contact loose tape, which may contain asbestos, if opened. The panel cover was not removed and the panel was not inspected. Further evaluation of the panel is needed when proper access is provided.
- The panel does not appear to be installed in an accessible or allowed area. The panel may have been installed prior to current standards. If any work is performed on the panel or the electric service the panel may need to be moved. Recommend consulting with an electrician for further advise regarding the panel location.

Blocked access

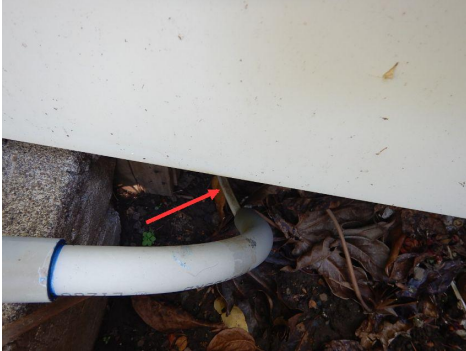
- Some junction box covers were missing, corrections are needed.
- Abandoned or disconnected wiring was visible in areas. The inspector was unable to confirm that this wiring has been completely disconnected and these wires could be or could become energized. All abandoned or disconnected wiring needs to be properly removed or terminated by a licensed electrician.
- **Improper wiring was visible and needs repair by a licensed electrician in the following areas:** At the exterior, In the crawlspace

Improper wiring

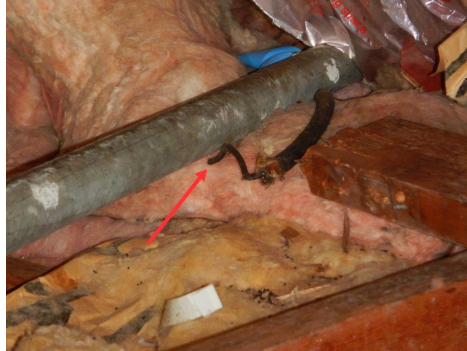
Abandoned wiring in attic

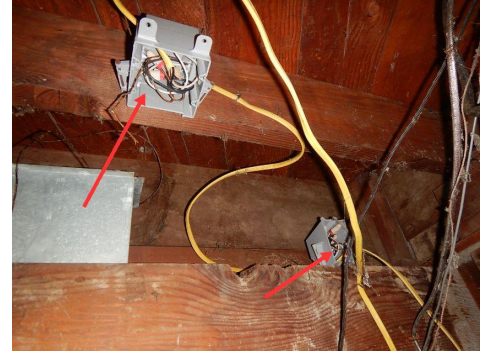
Open junction boxes

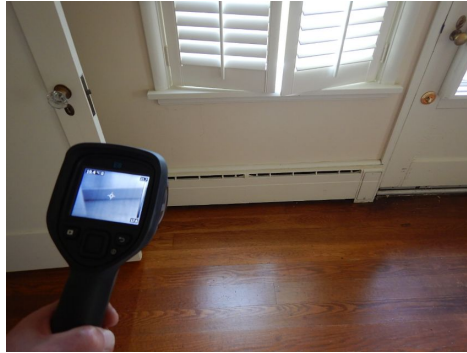
Radiator not heating

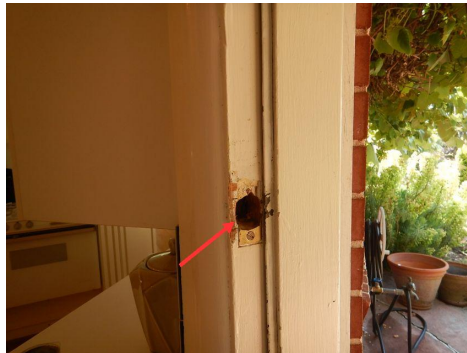
- Location:Kitchen area
- The older glass at the doorway does not appear to be tempered safety type. This is common at older doors but is a potential safety hazard. Consider having the glass at the door area replaced with tempered safety type.
- Some strike plates at the door jamb were damaged, repairs are needed.
- The lower portion of the dutch type door did not have a latch, the lower portion of the door will not stay shut.

Damaged strike plate

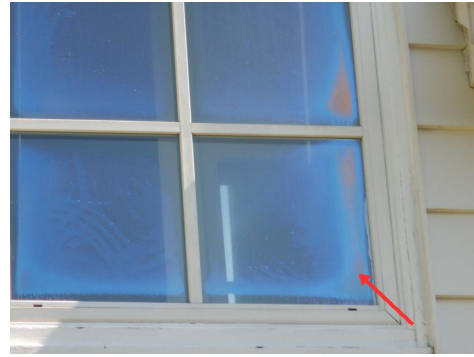
Fogged glass

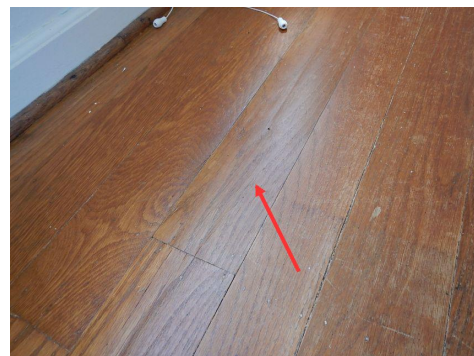
Warping at wood flooring

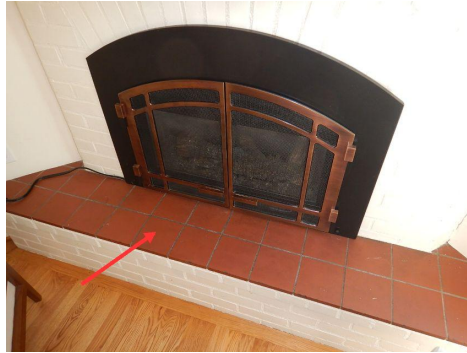
- The gas to this fireplace was turned off at the valve. The inspector does not turn on gas valves or light fires. Recommend verification of the fireplace operation and operating instructions.
- The hearth surface in front of the fireplace appears to be too small. Corrections will be needed if

the insert is removed and the fireplace is used for wood.

Small hearth for wood fireplace

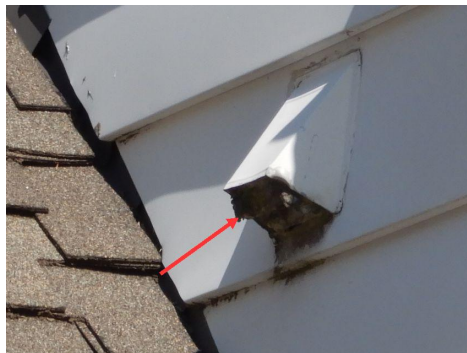
- The vent system appears to be blocked or full of debris and is a potential fire hazard, the vent system needs to be cleaned.

Blocked vent

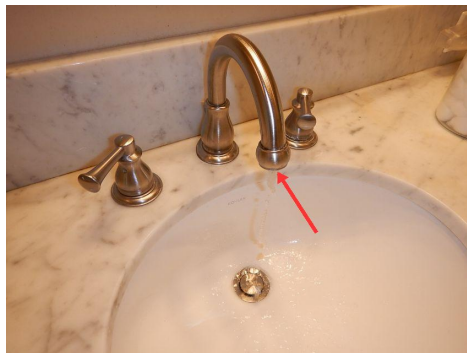
- Low water volume at faucet. This may indicate older restricted water supply pipes in the building. This condition needs to be monitored and improvements to the buildings plumbing may be needed.

Low water volume

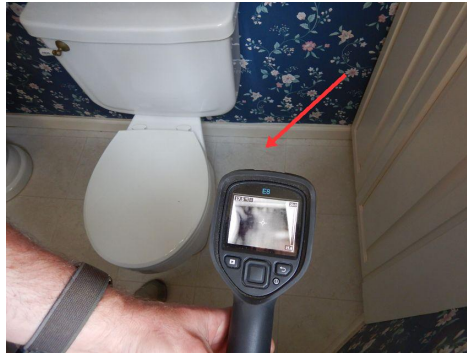
- Moisture stains or damage was visible at the flooring. Recommend further evaluation by a licensed contractor and repairs as needed.

Evidence of moisture in floor
